INVESTIGATION

Bryson Crash

INVESTIGATION OF THE BRYSON CRASH

EXPERT'S REPORT

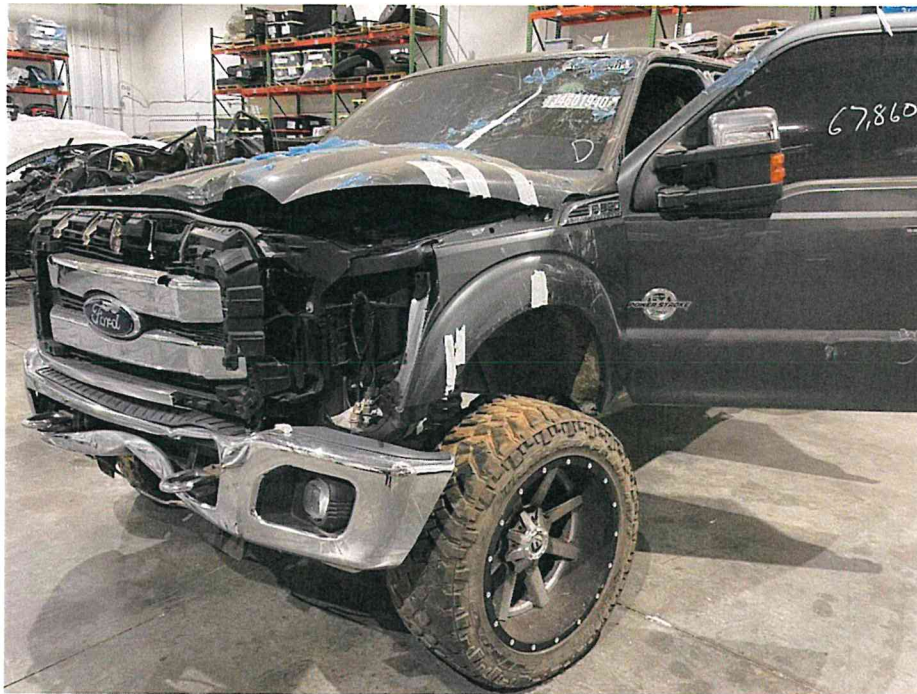
- Minimal deformation to the front end of the F250 (Image 6).
- Local deformation to the center of the bumper in a vertical direction. The presence of two Secondary Energy Absorbing Structure (SEAS) brackets showing minimal deformation or contact marks (Images 7 & 8).

Image 6 – F250 Front End Damage

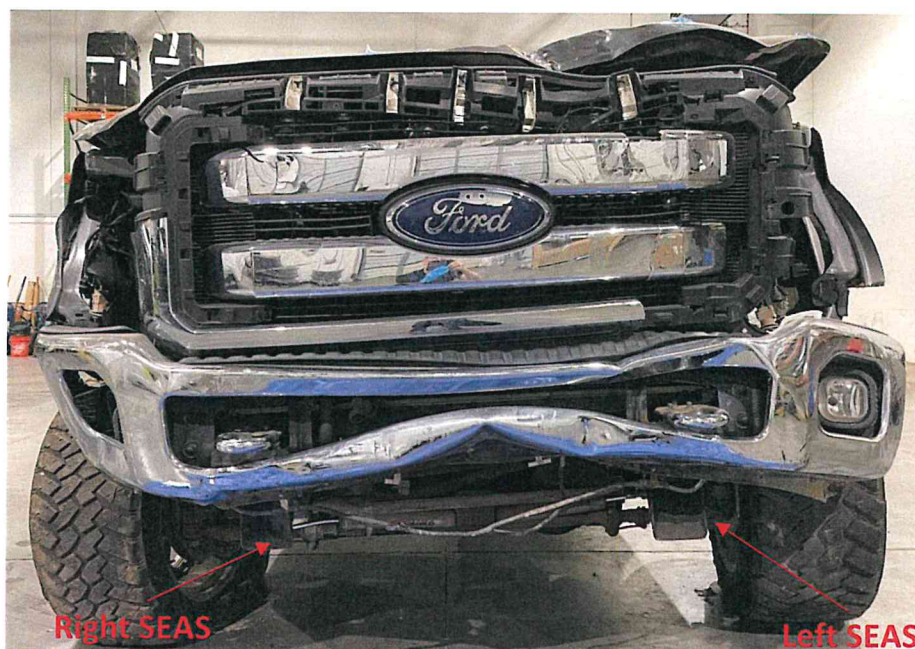
Image 7 – Bumper Damage & Secondary Energy Absorbing Structure (SEAS)

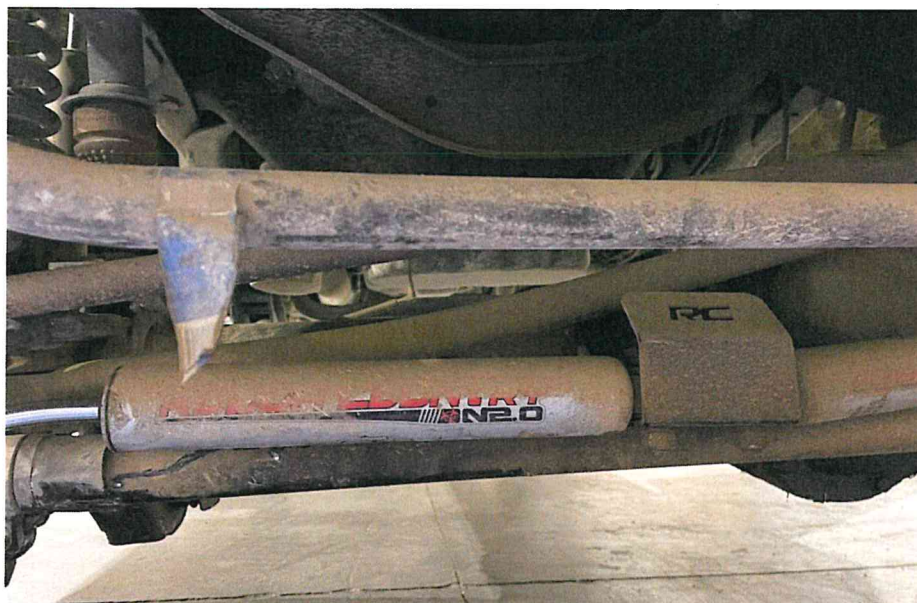
- Lack of crush or deformation to the Primary Energy Absorbing Structure (PEAS) or frame rail and no evidence of contact between the SEAS bracket and the frame (Image 9).
- Fitment of a Rough Country suspension lift kit to raise the vehicle's ride height (Image 10).

Image 10 – Rough Country Lift Kit Components

Elliott's F250 was fitted with RC item 567.20, a 4.5-inch lift kit. In the installation instructions, Rough Country states that the *"suspension system was developed for 35x12.5x17 tire"*. Elliott's F250 was fitted with 325/50R22 tires. These tires have an overall diameter of 34.8 inches and width of 12.8 inches – providing very similar overall dimensions to those specified by Rough Country.

Elliott's F250 frame height from ground was measured during the inspection and then corrected for the flat tire and occupant weight using NHTSA compliance test data. This resulted in the bottom of the frame rail (PEAS) being about 24 inches from the ground, exceeding the upper 20-inch limit of the Part 581 bumper region. The height of the bottom of the SEAS bracket was about 18 inches from the ground – no longer meeting the requirement of the EVC that the SEAS should have a lower edge no higher than the lower 16-inch limit of the Part 581 bumper region. A standard, non-lifted 2016 F250 frame rail overlaps the Part 581 bumper region, and the SEAS bracket is about 13 inches from the ground. **The Rough Country lift kit fitted to Elliott's F250 made it non-compliant with the EVC.**

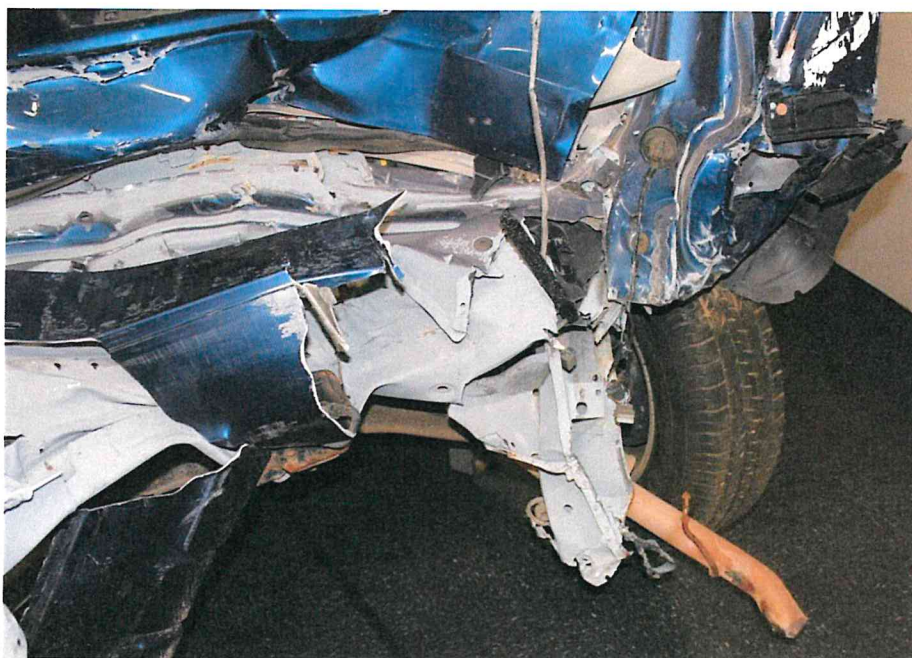
- The entire rear of the body has been significantly compressed with the D pillar collapsed onto the C pillar and both deformed forward in vehicle, exposing the rear wheels (Image 11).
- The lower rear body structure has been compressed forward in vehicle and both rear rails exposed with the floor panel and lower crossmember deformed forward in vehicle and peeled off from the rails (Images 12, 13 and 14). Neither rail exhibits significant axial collapse with local bending of the members only and the right rail bent downward. The rear bumper beam is detached. The liftgate has deformations either side of the rear window that are consistent with direct contact damage.
- The rear trunk space has been compressed longitudinally and the rear seats deformed forward in vehicle toward the front passenger seats reducing the second-row occupant space (Image 15).

Image 13 – Ford Escape Right Rear Rail

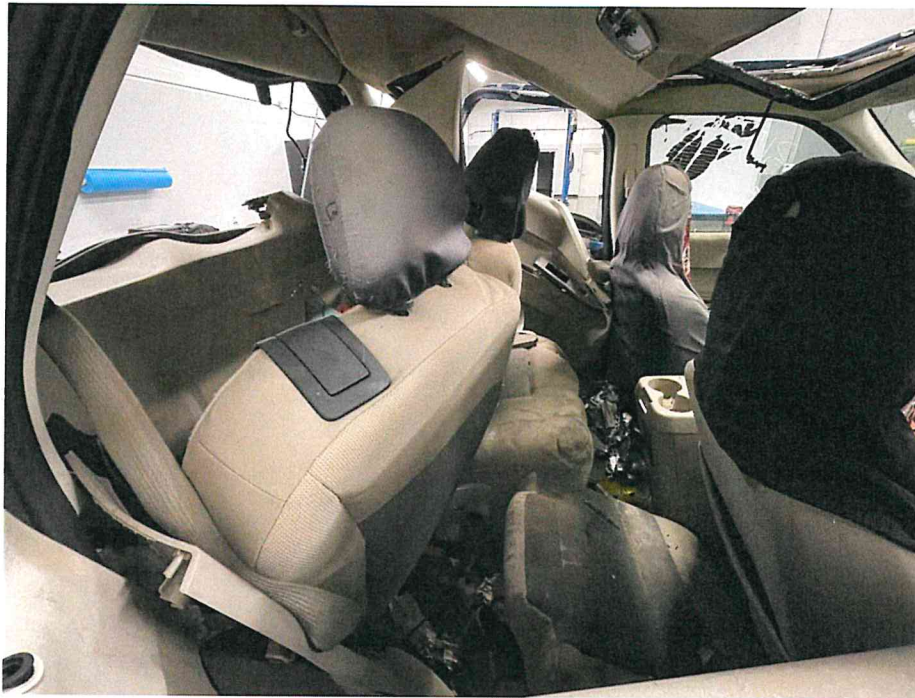
Image 15 – Ford Escape Rear Seats

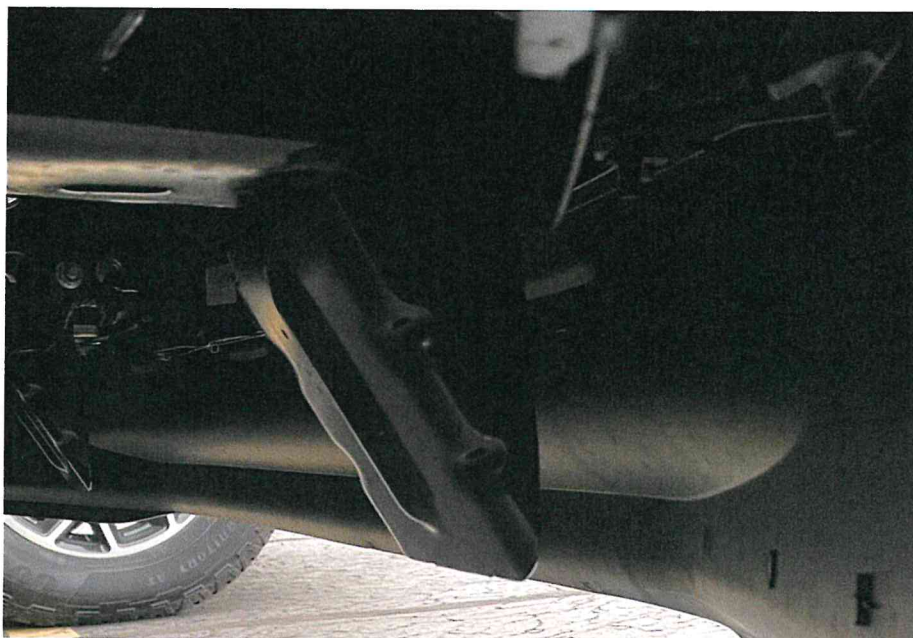
Image 25 – 2022 Ford F350 SEAS Bracket & Frame Rail

As LTV sales have steadily increased and the risks associated with incompatibility of LTVs and other vehicle types has been studied by regulators and OEMs, a standard of care that improved LTV design and provided less risk to other road users was developed. The EVC agreement has been successful in ensuring reduced fatalities of occupants in vehicles that collide with LTVs since it was introduced in 2003. Ford and other OEMs continue to fit LTVs with SEAS, including the current generation of Ford Super Duty – see Image 25. **Rough Country violated the standard of care for LTV compatibility by providing lift kits that rendered the OEM's compatibility designs ineffective, without warning the owner of the vehicle or providing a way to maintain the vehicle's compatibility with the lift kit.**

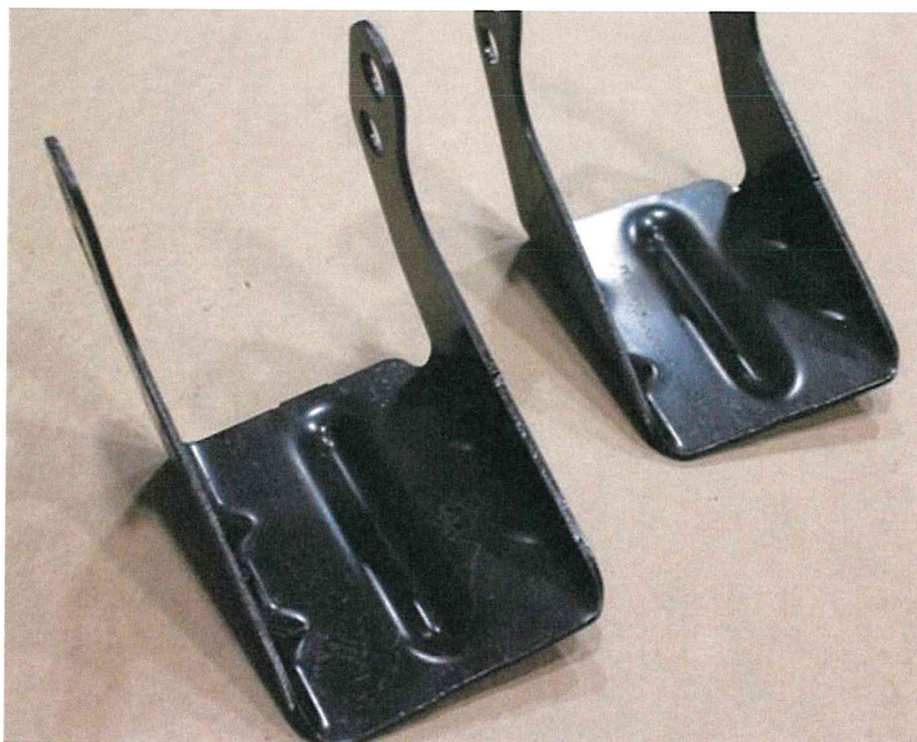
Image 26 – 2016 Ford F250 SEAS Brackets

The SEAS brackets fitted to the 2016 Ford F250 (image 26) are relatively simple, stamped U-shaped brackets that are bolted to the main frame rail in two locations each. Each bracket costs about \$25 when

purchased from a Ford dealer as a replacement part. Rough Country could have developed components to maintain vehicle compatibility and could have advised customers to fit the new components when using a lifted vehicle on public roadways. Rough Country has the capability to design and produce new versions of the U-shaped brackets with modified geometry to account for the ride height increase of the lift kit and to ensure it satisfied the 16 inch height and 100 kN load requirement of the EVC agreement. The SEAS brackets are bolted to the frame rail and so removing and replacing them with new components is straight forward and consistent with how the lift kit is installed. The alternative design of new SEAS brackets would not affect the utility of the vehicle on-road and could be easily removed for off-road use, if necessary.
